**DYNAMIC RESPONSE AND FAILURE ANALYSIS OF  
ALUMINUM CYLINDERS SUBJECTED TO UNDERWATER EXPLOSION**

**Kurt W. Nelson**  
**Lieutenant Commander, United States Navy**  
**B.S., Northwestern University, 1977**

**NAVAL POSTGRADUATE SCHOOL**  
**June, 1992**

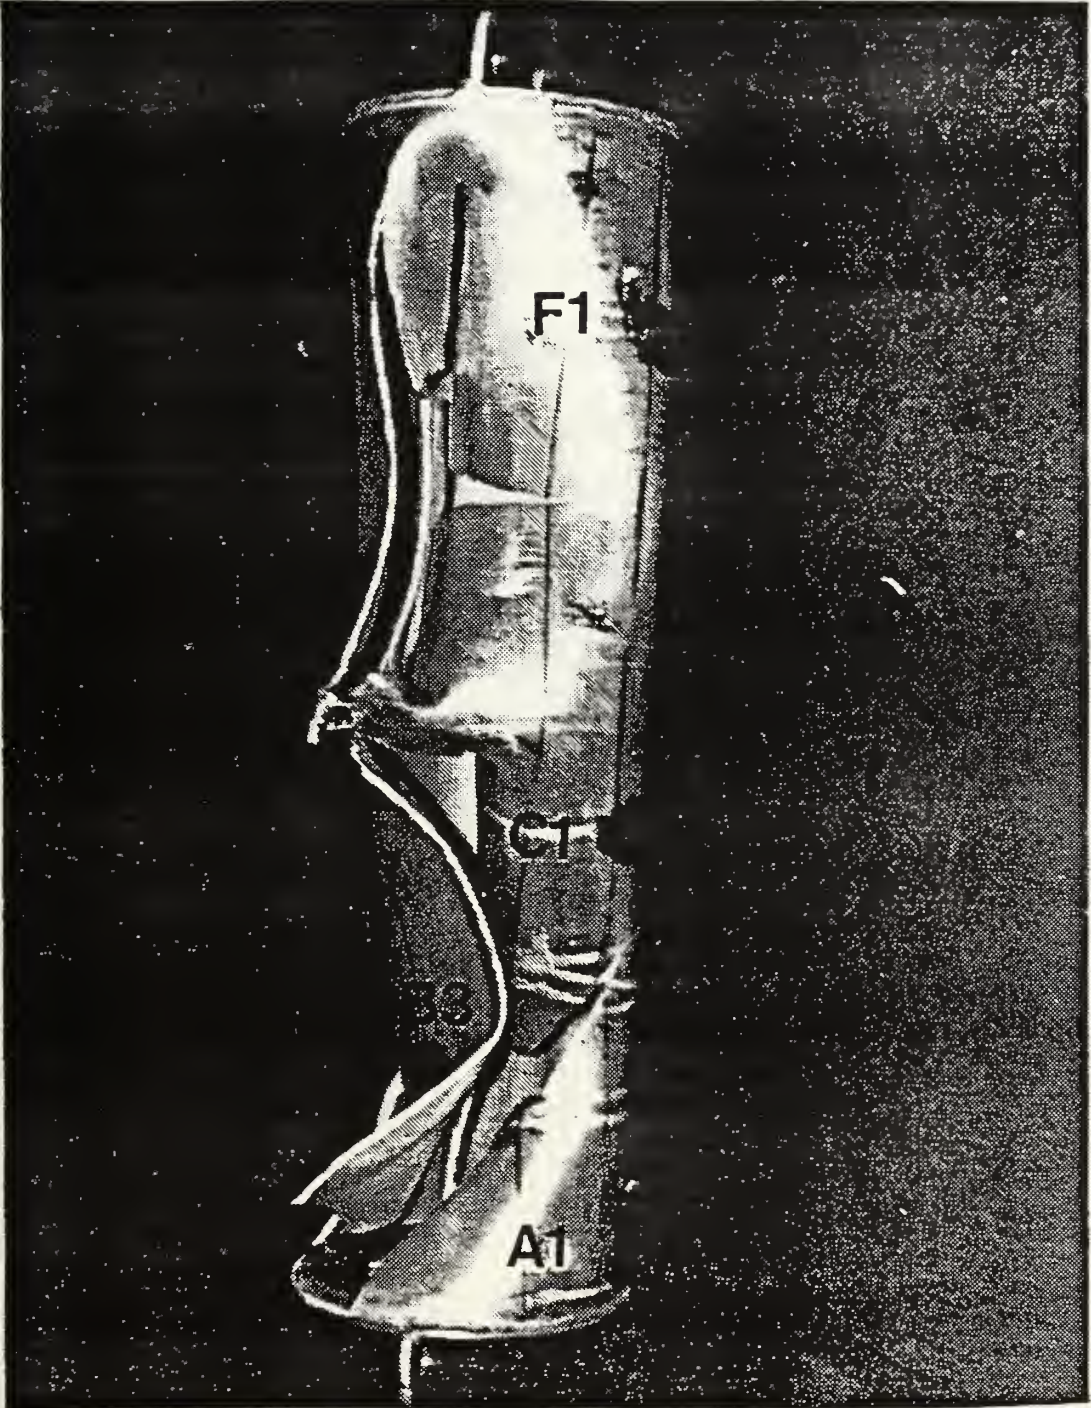
**Figure 8.** Damaged Cylinder Following End-On Attack  
(Lower Endplate Closest to Charge)

The cylinder subjected to the end-on shock wave suffered severe plastic deformation and collapse due to weld failure at the cylinder end nearest to the charge. The weld failure occurred near the longitudinal axis which contained strain gages B3, D3, and F3. As a result, strain gage readings from these three instruments were most severely affected by the material failure. A six-inch section of the aluminum cylinder located between gage locations 2 and 3 was physically separated from the near endplate due to the force of the shock wave. A large crack extended the length of the cylinder beginning at the location of the weld failure. The ring stiffener was fractured with evidence of heavy plastic deformation prior to failure. Two additional cracks in the circumferential direction were also noted near the ring stiffener. In addition, a six-inch length of cylinder displayed local buckling near the locations of gages A2 and B2.

The cylinder failure near strain gage locations B3, D3 and F3 had a significant effect on the experimental results. Axial strain for gages D3 (Figure 17) and F3 (Figure 23) were smaller in magnitude than expected from the numerical model which did not incorporate failure criteria. The stress relief which occurred as a result of the nearby failure would account for these low strain values. Hoop strain at location B3 (Figure 14) was significantly greater than the predicted value due to the collapse of the cylinder walls in the immediate area. In contrast, the hoop strain at location D3 (Figure 18) was lower in magnitude than the predicted value due to nearby failure of the ring stiffener. Axial and hoop strain values at gage location F3 (Figures 23 and 24) were also smaller than expected due to the stress relief afforded by the nearby crack.

and hoop strain values at gage location F3 (Figures 23 and 24) were also smaller than expected due to the stress relief afforded by the nearby crack.

The weld failure and subsequent crack propagation seems to have occurred approximately two milliseconds after shock wave arrival. The best indication of the time of failure can be seen at location B3 (Figure 14). Normally, the maximum compressive hoop strain occurs within the first millisecond after shock wave arrival. In this case, the maximum compressive strain occurred well after two milliseconds. The good correlation between actual and predicted strain values up to two milliseconds indicate that cylinder integrity was probably maintained until this time.

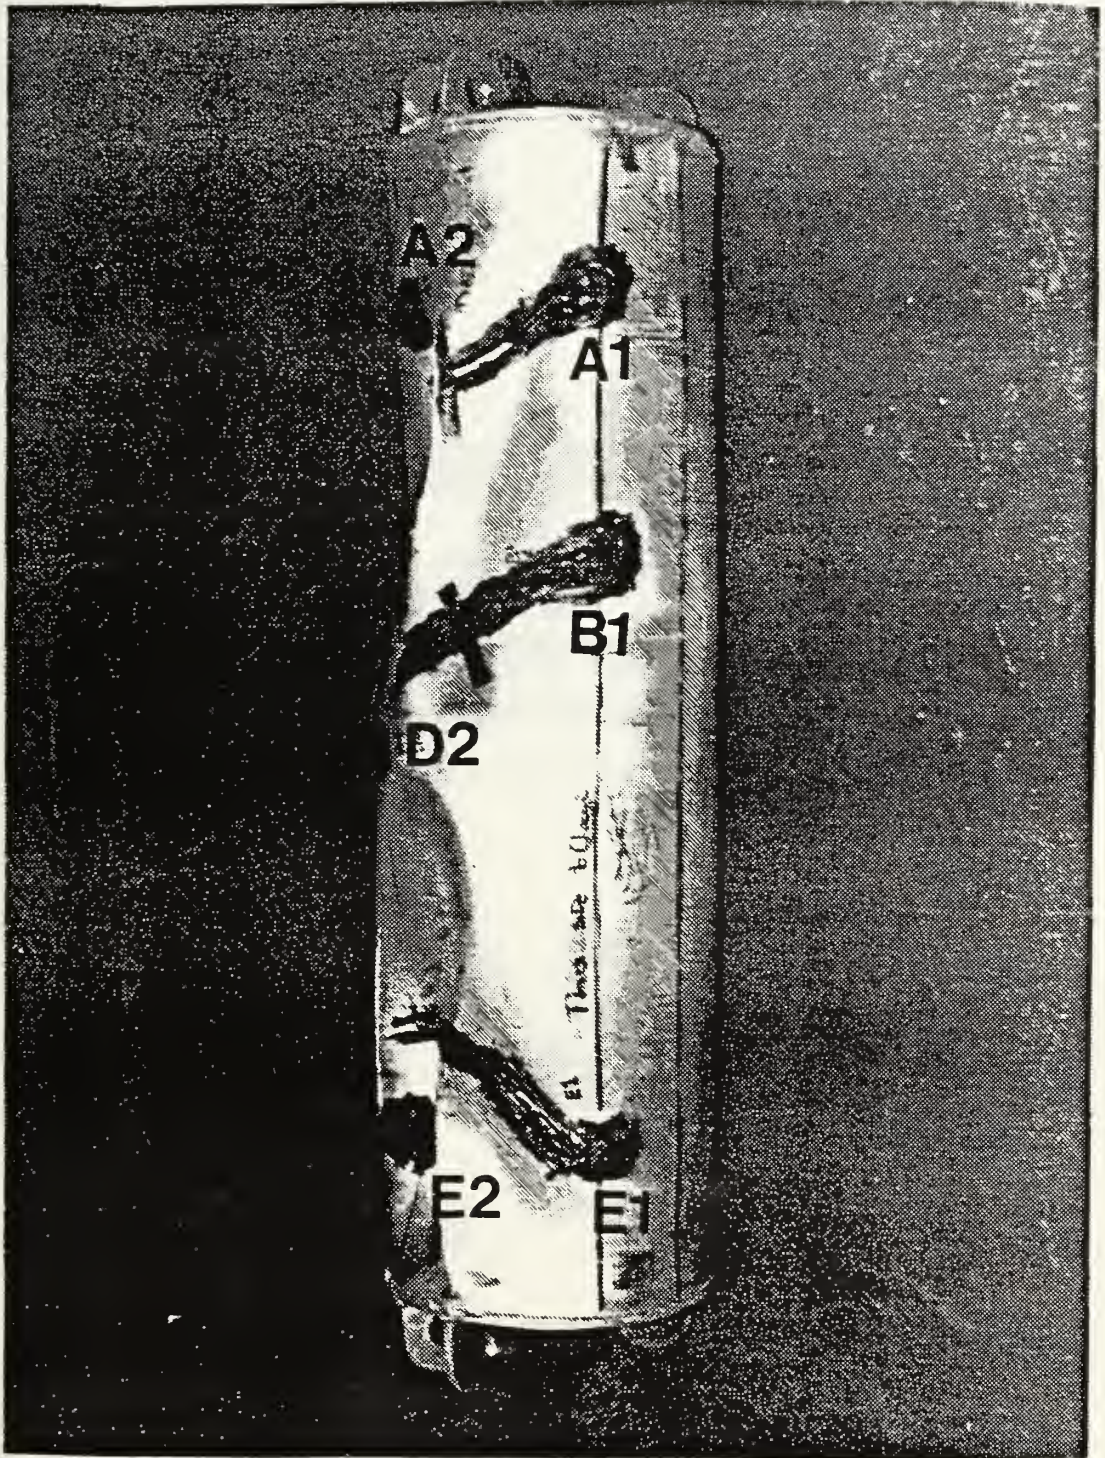
**Figure 25. Damaged Cylinder Subjected to Side-On Attack  
(Charge Location to Right of Cylinder)**

The cylinder subjected to the side-on attack also displayed cracks and local buckling in several areas. The top of the cylinder near gage location axis 2 displayed fairly symmetric cracks on both sides of the ring stiffener. The cylinder was ruptured between gage locations A2 and B2. Local buckling was noted in several places on the bottom of the cylinder. A picture of the damaged cylinder is shown in Figure 25. Side-on explosion strain-time history results are shown in Figures 26 through 35.

The stress relief and resultant low values of plastic strain near the cylinder cracks (location 2) was observed as in the end-on attack case. Axial strains at locations A2 (Figure 27) and D2 (Figure 32) show very little plastic deformation. Other strain information at this location was lost due to gage failure.

The failures in the cylinder probably began about 1.5 milliseconds after shock wave arrival. As previously mentioned, the strain gage output from location A1 was lost when gage wires were severed by a nearby cylinder crack. The axial strain plot at

location A1 (Figure 26) showed large compressive strain at about 1.5 milliseconds followed by a rapid rise to tensile strain. The oscillations noted at about 3.0 milliseconds are a consequence of the Butterworth filtering technique and are not indicative of actual strain at this location. Unfiltered data showed that this excursion into tensile strain was a result of gage failure. Therefore, the large axial compressive strain in the cylinder at 1.5 milliseconds was quickly followed by the material failures.

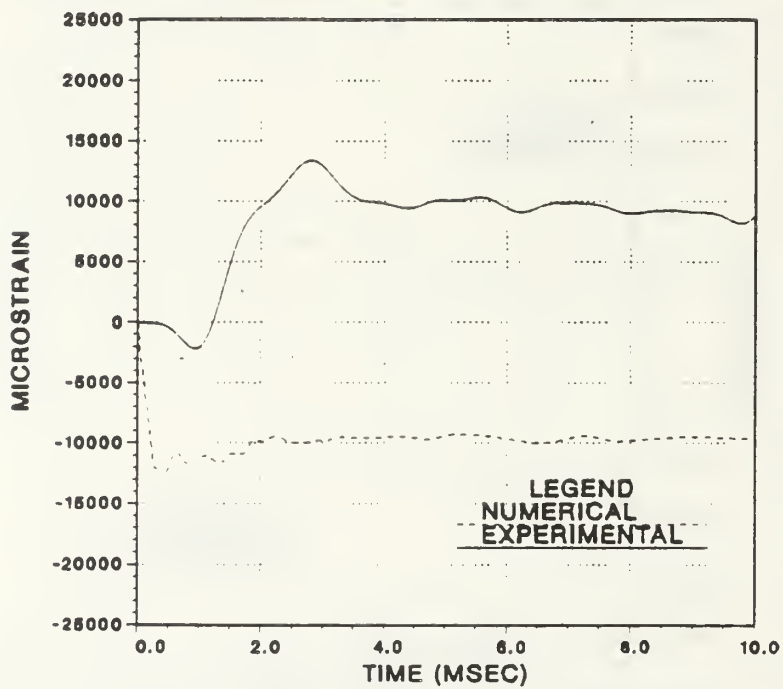
Figure 35. Side-On Explosion Hoop Strain at Gage Location E1

The tensile hoop strain observed at gage location E1 (Figure 35) was not well-predicted by the numerical model. The stiffness of the endplate and high inertial force which it imparts to the cylinder walls should produce a compressive hoop strain at this location. Sensitivity analyses with attack geometry variations and mesh density effects were investigated in an attempt to explain this behavior. The lack of reliable strain data at symmetric locations A1 and E3 hampered further analysis. Axial strain results at location E1 (Figure 34) were also quite different. Most likely, the behavior at location E1 was a result of the failures near locations D2 and E2 at top of the cylinder. This effect will be discussed in more detail in section IV.

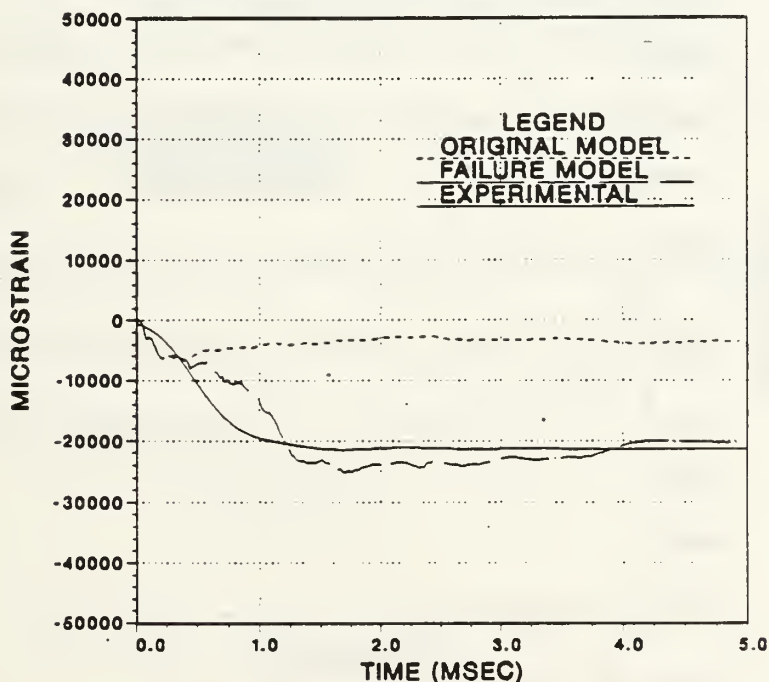
Figure 84. Side-On Explosion Axial Strain at Gage Location B2 with Failure Criteria.

A plot of axial strain at location B2 is shown in Figure 84. Unfiltered experimental data values indicated that the axial strain magnitude was probably saturated at about 2.0 milliseconds. Thus, the maximum strain magnitude at this gage location would be in excess of the values shown in Figure 84 at times beyond 2.0 milliseconds. Nevertheless, the use of failure criteria produced improved qualitative results at early times compared to the original model without failure criteria.

The initial element failures at 0.4 milliseconds were also reflected in the strain time-history plots. As shown in Figures 84 and 85, the original model and failure model strain predictions are almost identical until 0.4 milliseconds which corresponds to the failure time of the first element. The strain prediction curves diverge after the first failures occurred in the failure model.

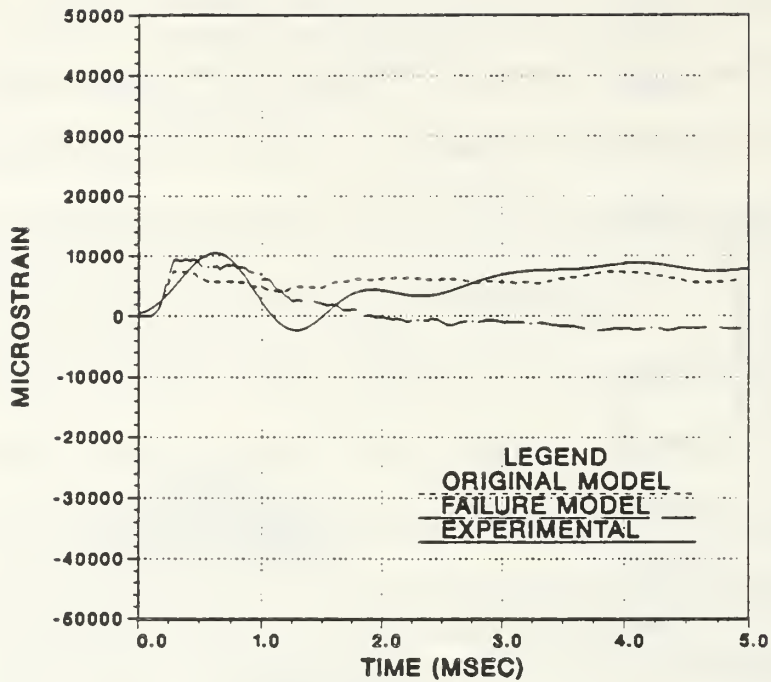
Figure 85. Side-On Explosion Hoop Strain at Gage Location B2 with Failure Criteria.

In a similar manner, numerical results with the failure model at location B2 more accurately predicted the experimental hoop strain response as shown in Figure 85. This strain gage probably failed at about 1.0 millisecond based upon the unfiltered experimental data so strain values after this time are not considered reliable. However, the improvement in the early time response is still significant.

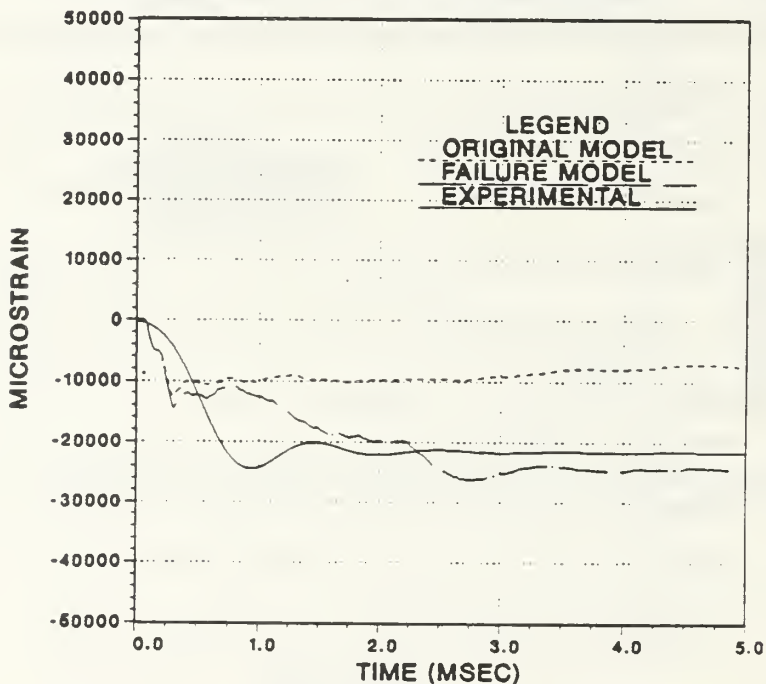
Figure 86. Side-On Explosion Axial Strain at Gage Location D3 with Failure Criteria.

Improvements in numerical strain predictions at gage location D3 were less significant as shown in Figures 86 and 87. Both numerical models poorly predicted the transient behavior of the cylinder but provided a reasonably good estimate of the actual strain values near 5.0 milliseconds. The close proximity of the ring stiffener to location D3 may account for the large strain variations observed in the experimental results.

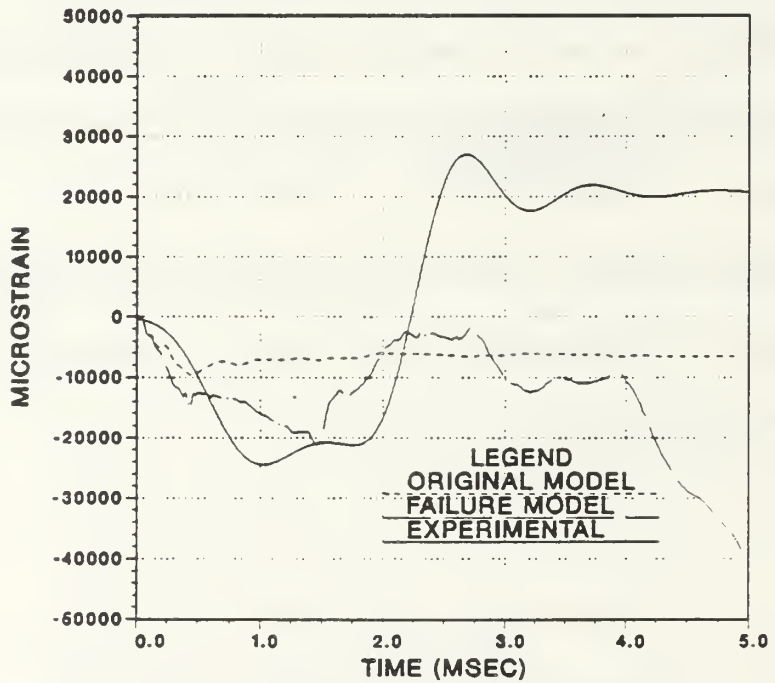
Figure 88. Side-On Explosion Axial Strain at Gage Location A2 with Failure Criteria.

The response of the cylinder adjacent to an imperfection site is shown for gage location A2 in Figures 88 and 89. Axial strain at location A2 (Figure 88) rapidly rises to the strain gage response limit of 50,000 microstrain within 1.5 milliseconds. Since even the static failure strain value for 6061-T6 aluminum is only about 70,000 microstrain, material failure at this location would soon occur. The hoop strain results (Figure 89) show a better comparison with experimental results up until 1.5 milliseconds due to nearby failures. The severe increases in strain at this location are attributable to stress redistribution following the failures in adjacent imperfection zone elements at about 0.4 milliseconds.

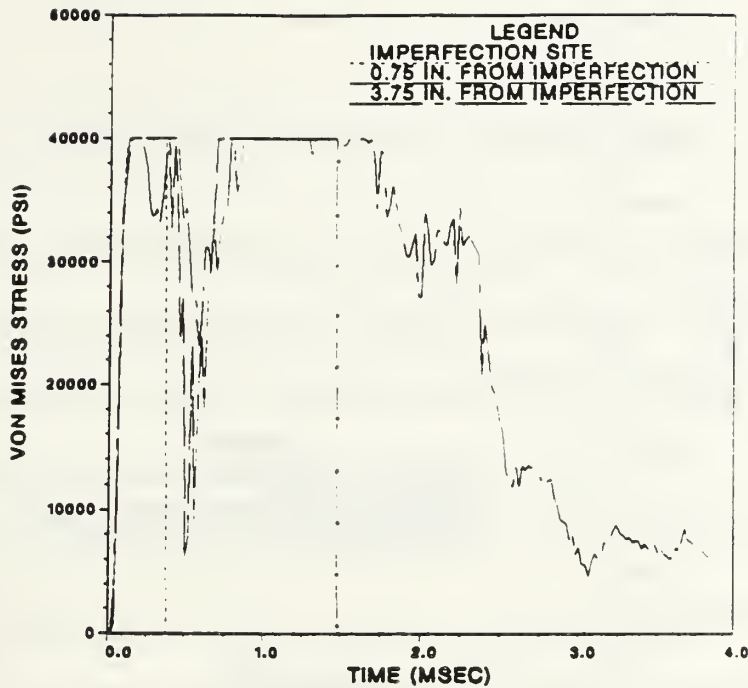
Figure 90. Effective Stress Near Failure Zone Adjacent to Gage Location A2.

The structural response to a failure can be best seen from the effective stress plot shown in Figure 90. This plot shows how stresses near a failure are relaxed and redistributed near a crack zone.

At the site of a reduced thickness element, or imperfection zone, the effective stress rapidly rises to the yield stress value of 40,000 psi after arrival of the compressive shock wave. The imperfection site experiences stress concentration due to the reduced thickness. Within 0.4 milliseconds, this element undergoes enough plastic strain to reach the failure value. The effective stress drops to zero as the element loses its capability to carry load due to the creation of a free surface at the crack location.

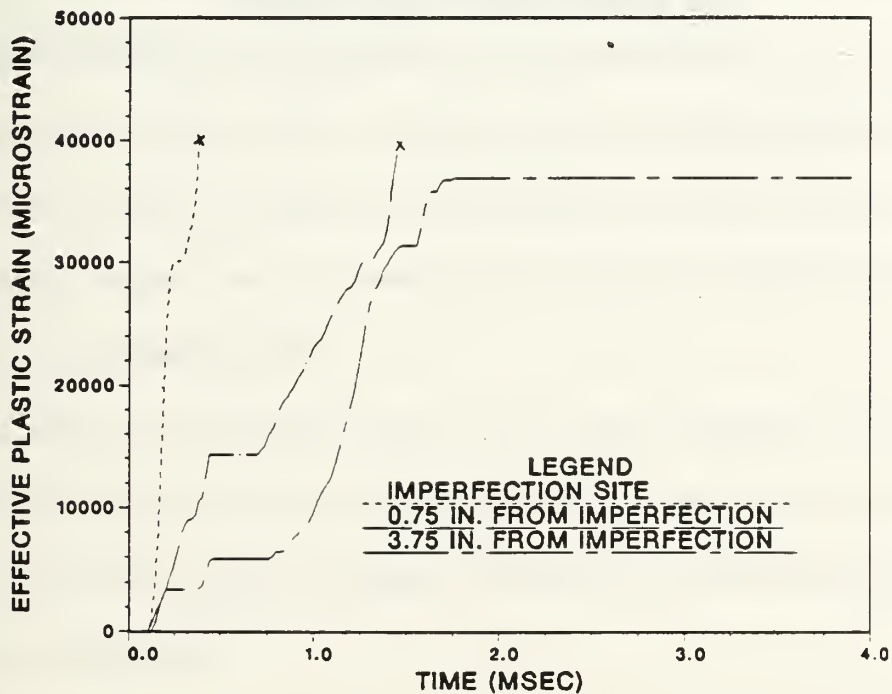
At 0.75 inches from the imperfection site in the circumferential direction, the effective stress again rises to the yield stress value and remains there as the element undergoes plastic strain. This position corresponds to gage location A2. At 0.4 milliseconds, however, this element undergoes a rapid stress reduction as a result of the failure in the adjacent element. This stress relaxation is due to elastic strain recovery. However, since fluid particle pressure is still acting on the cylinder at 0.5 milliseconds, the stress rapidly rises again to the yield stress. This element continues to undergo plastic strain until failure occurs at about 1.5 milliseconds.

At 3.75 inches from the imperfection site in the axial direction, similar behavior occurs out to 1.5 milliseconds. This position corresponds to gage location B2. This element, however, maintains its ability to carry load because the redistribution of the stress is made over a larger number of elements. A reduction in stress is noted at about 2.1 milliseconds when surface cutoff occurs.

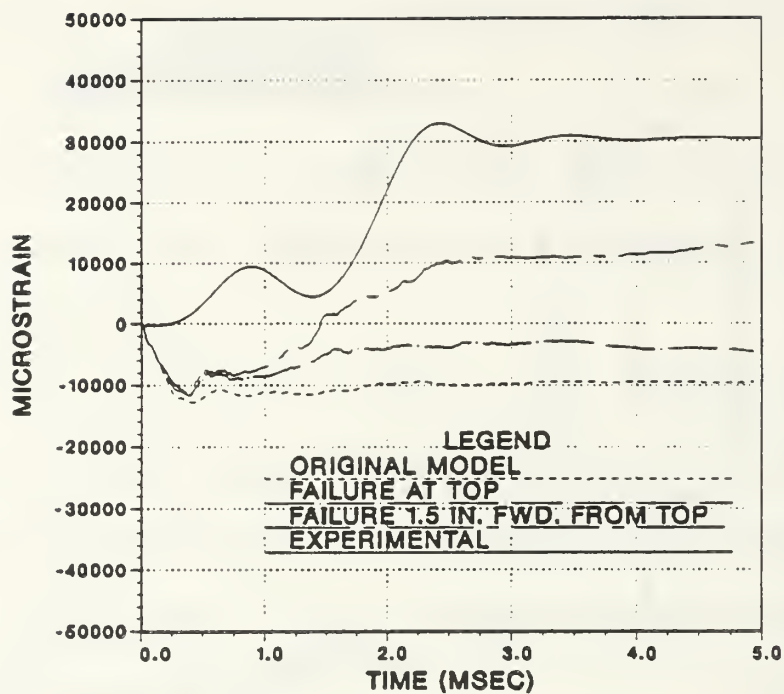
**Figure 92.** Side-On Explosion Hoop Strain at Gage Location E1 with Different Failure Zone Locations.

The sensitivity of cylinder response to the location of the imperfection zone can be seen in Figure 92. The hoop strain at location E1 was poorly predicted by both the failure model and the original model. The movement of the failure zone one element row or 1.5 inches towards the front of the cylinder resulted in a significant improvement in strain comparisons. Thus, the cylinder response was seen to be sensitive to element thickness reduction, imperfection location and imperfection zone size. In addition, failures which occur in one area of the cylinder can result in a vastly different response at other locations. The failures which occurred at the top of the side-on attack cylinder could have caused the tensile hoop strain noted in Figure 92.
